California Levee Vegetation Research Program

Influence of Tree Roots and Mammal Burrowing Activity on Levee Integrity:

Volume 4. – Field Evaluation of Burrowing Animal Impacts and Effectiveness of Remedial Measures

Geotechnical Engineering
University of California, Berkeley
Report UCB GT 13-03 vol. 4

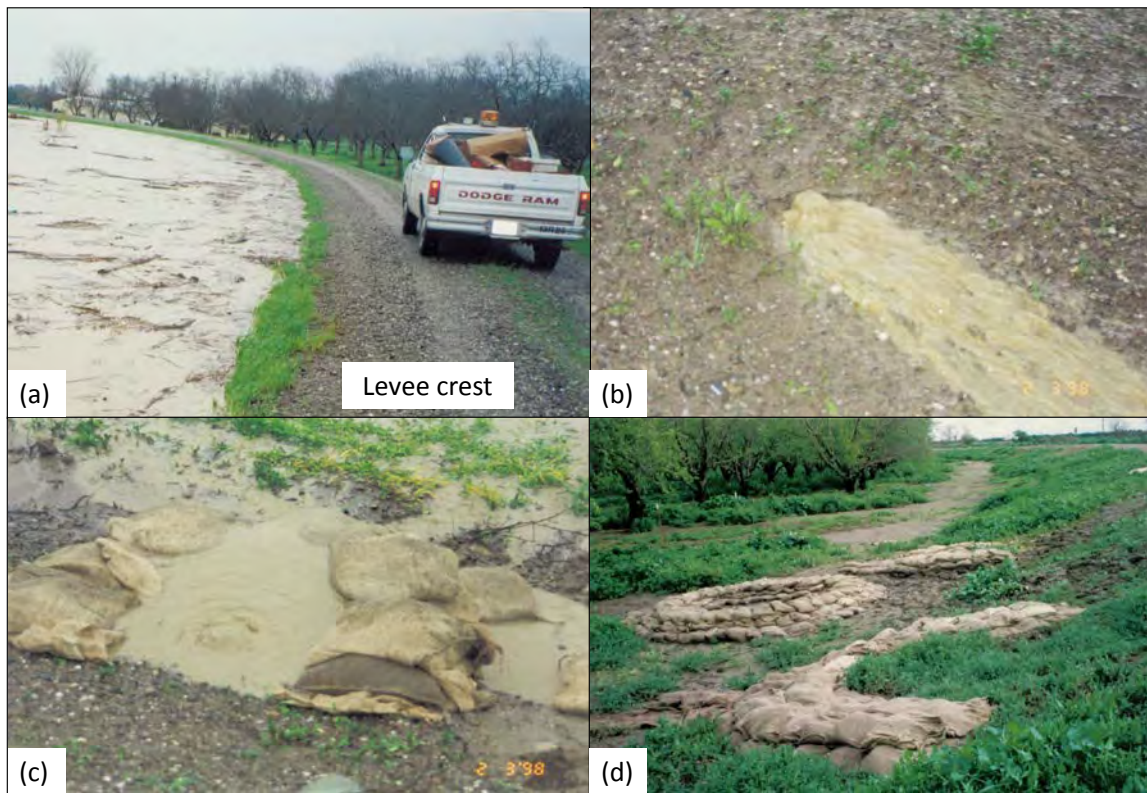
Figure 4-2. High water on the clayey levee site during 1998. Images courtesy Al Romero, DWR

This site is of great importance to the history of grouting practices in California. During the floods of March 1998, this levee experienced water levels within 0.5 meters of the crown (Figure 4-2a). Sustained high water resulted in several sand boils and through-seepage on the clayey embankment (Figure 4-2b, c and d). This near failure was attributed to the presence of mammal burrows, which led to the beginning of current DWR grouting and maintenance programs. Since 1998, this levee has been used as a test site by the DWR, to perfect grouting techniques and mix compositions. Grouting takes place at the end of the spring season, and records of grouting volumes and number of burrows have been kept and were provided by DWR personnel (Figure 4-3). The figure shows that the volume of grout required to fill active or new burrow holes along this stretch of levee decreases every year despite having a food source next to the levee. The fact that several holes were flowing muddy water during the 1998 flood indicates that some of these burrows were completely penetrating the embankment and piping was occurring.

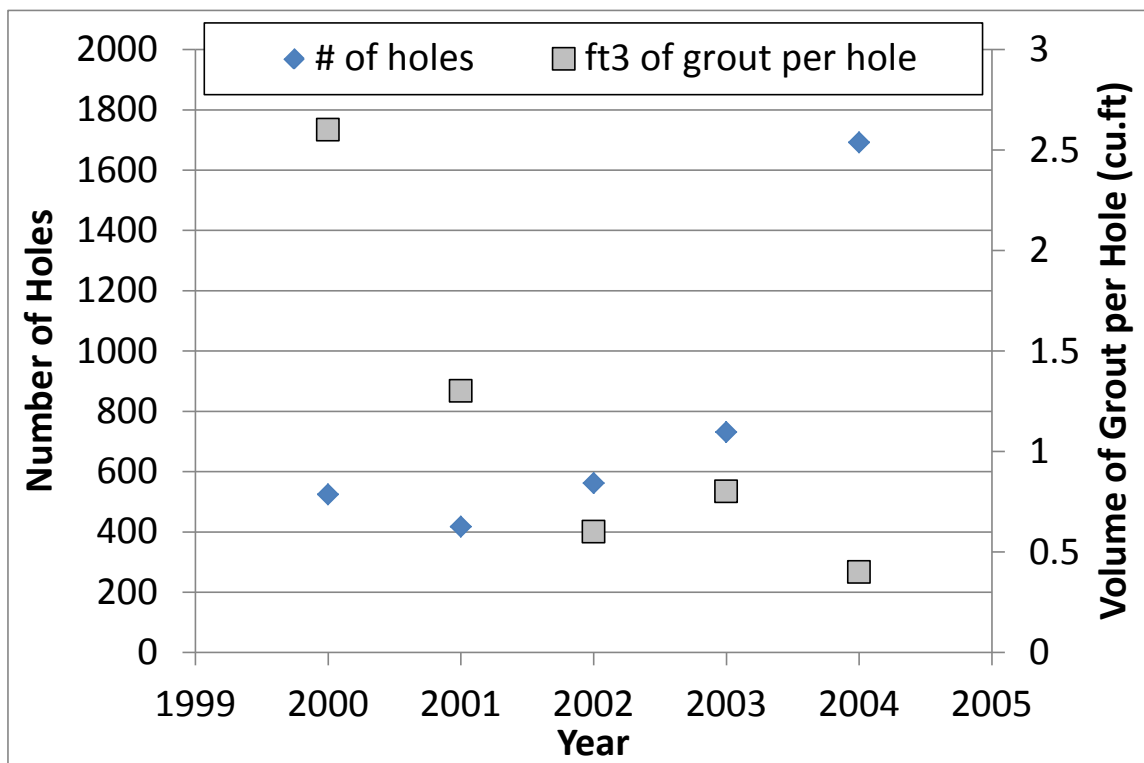
Figure 4-3. Volume of grout used on the clayey levee site from 1995 to 2004 (data provided by Al Romero, DWR)

The data in Figure 4-3 suggests that even though the number of burrows encountered along the levee reach under study had increased by approximately 300%, the amount of grout used per hole declined five-fold. Not shown on the plot is the amount of labor hours per hole, which declined from about two man-hours in 2000 to less than 0.5 in 2004. These results suggest that the adoption of a periodic burrow grouting program can mitigate the likelihood of a large burrow or network of burrows from penetrating a levee, along with a decreasing maintenance cost.

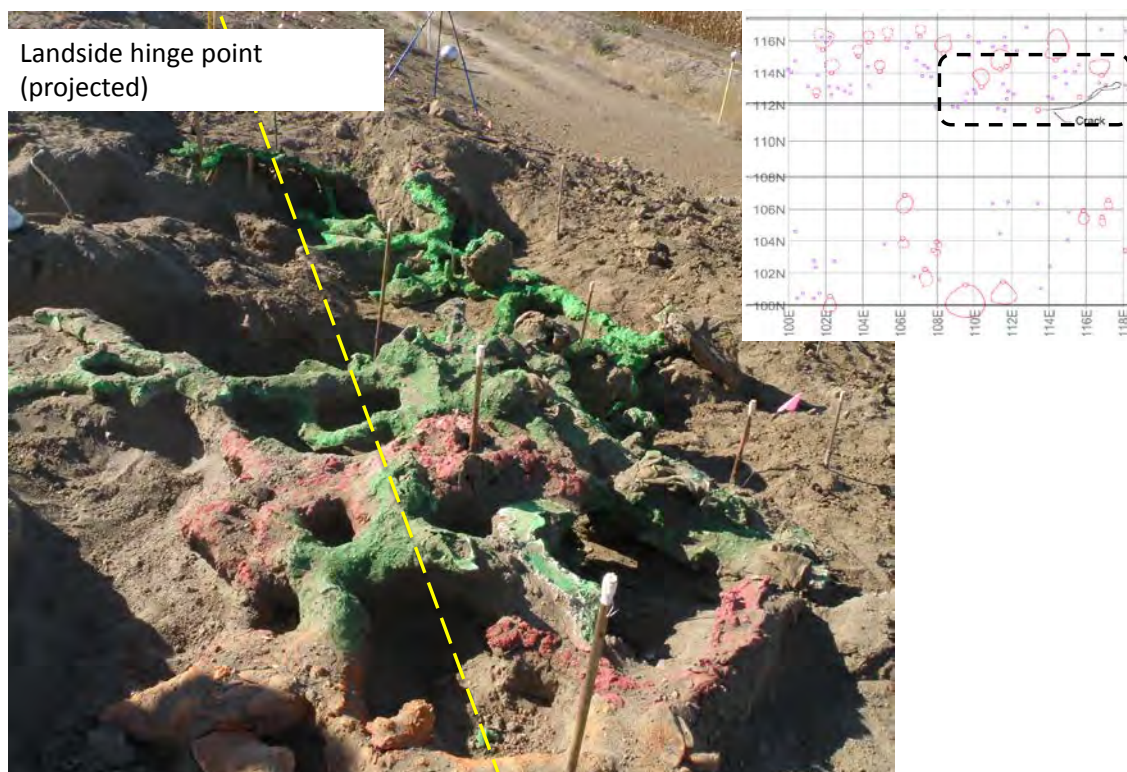
Figure 5-6. Oblique view looking upstream of main complex near landside edge of crown

The burrow complex extended upstream (top of Figure 5-6) and divided into two main tunnels of approximately 15 centimeters (0.5 ft) in diameter; the alignment of these tunnels dipped down approximately 50 centimeters (1.6 ft) and converged into a single tunnel that sharply increased in elevation at the end of the burrow system. Figure 5-7 shows a lateral view of the landside burrow complex at the end of the excavation activities, at which point the main intertwined portion (Figure 5-5) had been removed to expose deeper portions of the system.

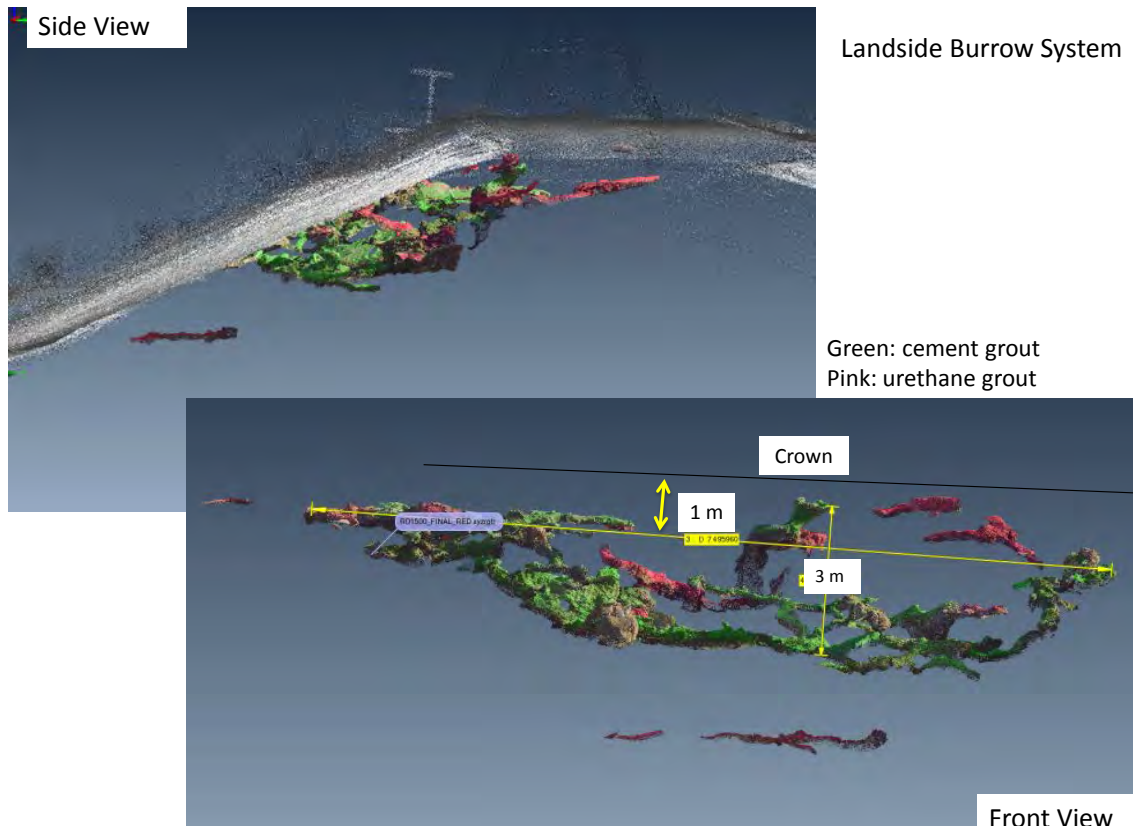
Figure 5-9. Close-up of landside burrow system (a) shows a cross section view, (b) a front view [1 m: 3.28 ft]

The figures below give testament to how intricate and large burrow systems can become if no grouting (or void filling) or species control is performed on a levee. The surveyed burrows extend for several meters in all directions, and even though a burrow extending from one side of the levee to the other was not encountered, the potential for wetting front instability and rapid saturation is clear given the large volume of voids generated within the embankment.

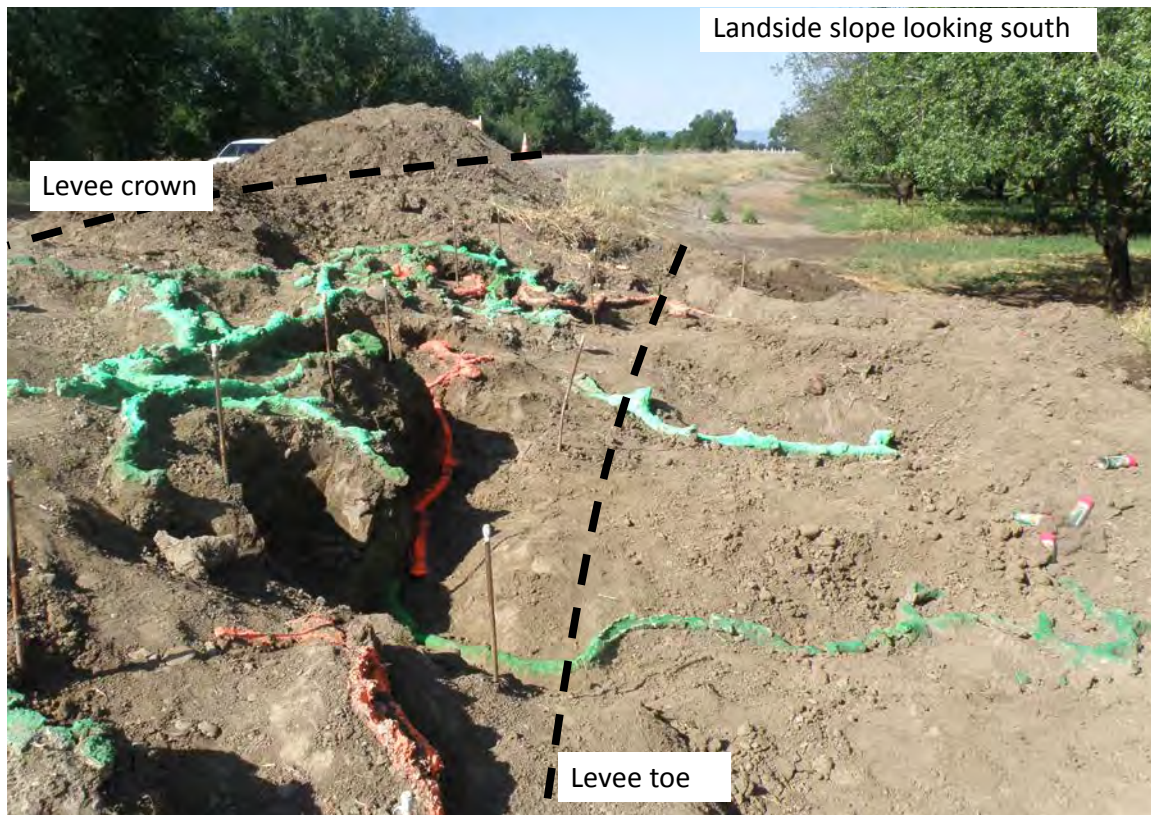
Figure 5-11. View of excavated landside slope on the clayey levee.

The burrow system encountered on the landside slope was similar to that on the Sandy Levee Site, with intricate and interconnected multi-level systems created by California ground squirrels and Pocket gophers. Most of the burrows coincided with a strip of grass (Figure 4-8) that is not mowed by the adjacent landowner, making it a food source for the pocket gophers. California ground squirrels, on the other hand, created larger burrows (10-15 cm in diameter) extending landward from the strip of grass toward the levee toes.

The majority of the burrows were found approximately 0.5 to 1.0 meters (1.6 to 3.3 ft) below the surface of the slope and crown, and only a few isolated burrows extended landward into the toe area, as shown on the right hand side of Figure 5-11. A single burrow was encountered extending from the waterside toward the landside slope (Figure 5-12 and Figure 5-13), approximately one meter below the elevation of the crown. This burrow was approximately 12 to 15 cm in diameter, and was grouted with cement-bentonite grout during a previous maintenance campaign. The grout was observed broken up and relatively friable, suggesting that the grout filling this hole belongs to early practices, when DWR used a higher percentage of bentonite (about 10%), which made the mix friable upon

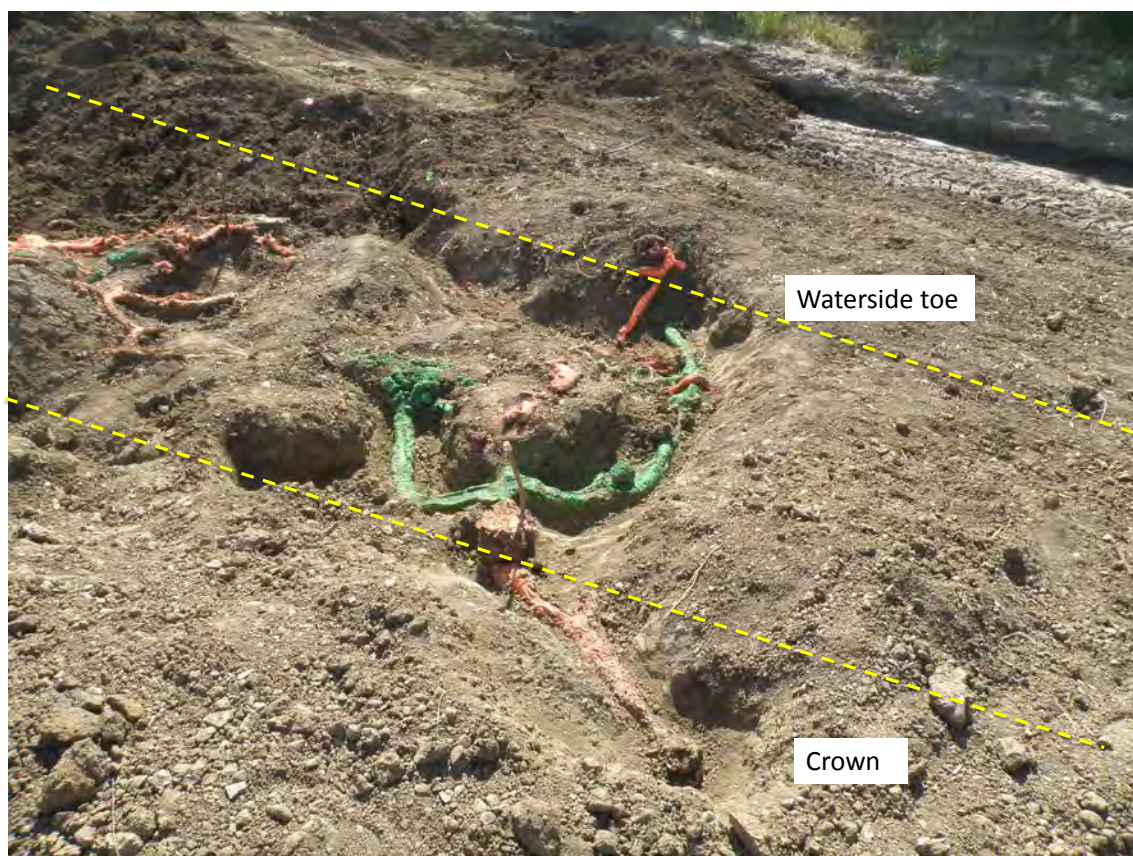
Figure 5-14. Oblique view of waterside burrow system

The waterside levee burrow system (Figure 5-14) was not as extensive as the landside and was comprised of a few isolated burrows, mostly filled with polyurethane grout. This trend is consistent with the observations from the sandy levee, where the majority of the burrows were encountered on the landside levee slope, which coincides with the slope nearest to the food source.

The waterside 'edge' of the completely penetrating burrow was encountered approximately 1 to 1.2 m (3.3 to 4 ft) below the levee crown, and it connected to a series of short burrows also filled with cement-bentonite grout.

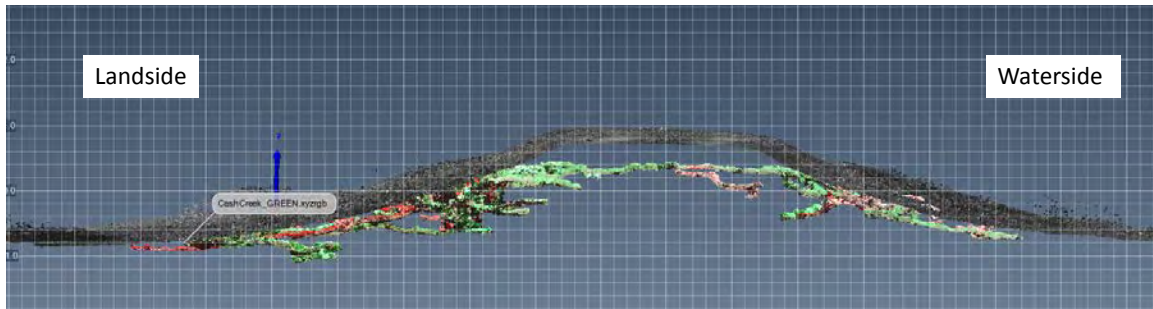
Figure 6-1. Cross section view of completely penetrating burrow through the clayey levee

The results of numerical simulations to assess the influence of animal burrows on the seepage performance of embankments, from the point of view of wetting front instability and soil piping are presented in Volume 5 of this report. Piping, which is considered an important threat to levee safety, is highly dependent on three factors: (1) flow through the porous media around the pipe, (2) length and size of the pipe, and (3) particle stability. The fact that animal burrowing has the capacity to create completely penetrating burrows eliminates the variable of flow through the porous media, since the full hydraulic heads from the riverside are encountered along the entire cavity with minimal energy loss, and piping potential becomes simply a function of flow velocity inside the pipe, which in turn is dependent on the head differential between the water surface on the riverside and the entrance to the pipe. Figure 6-1 and Figure 6-2 show a cross section and plan views of the completely penetrating hole and burrow system for the Clayey Levee Site. The penetrating burrow was encountered approximately one meter below the top of the levee, almost perpendicular to the levee alignment.

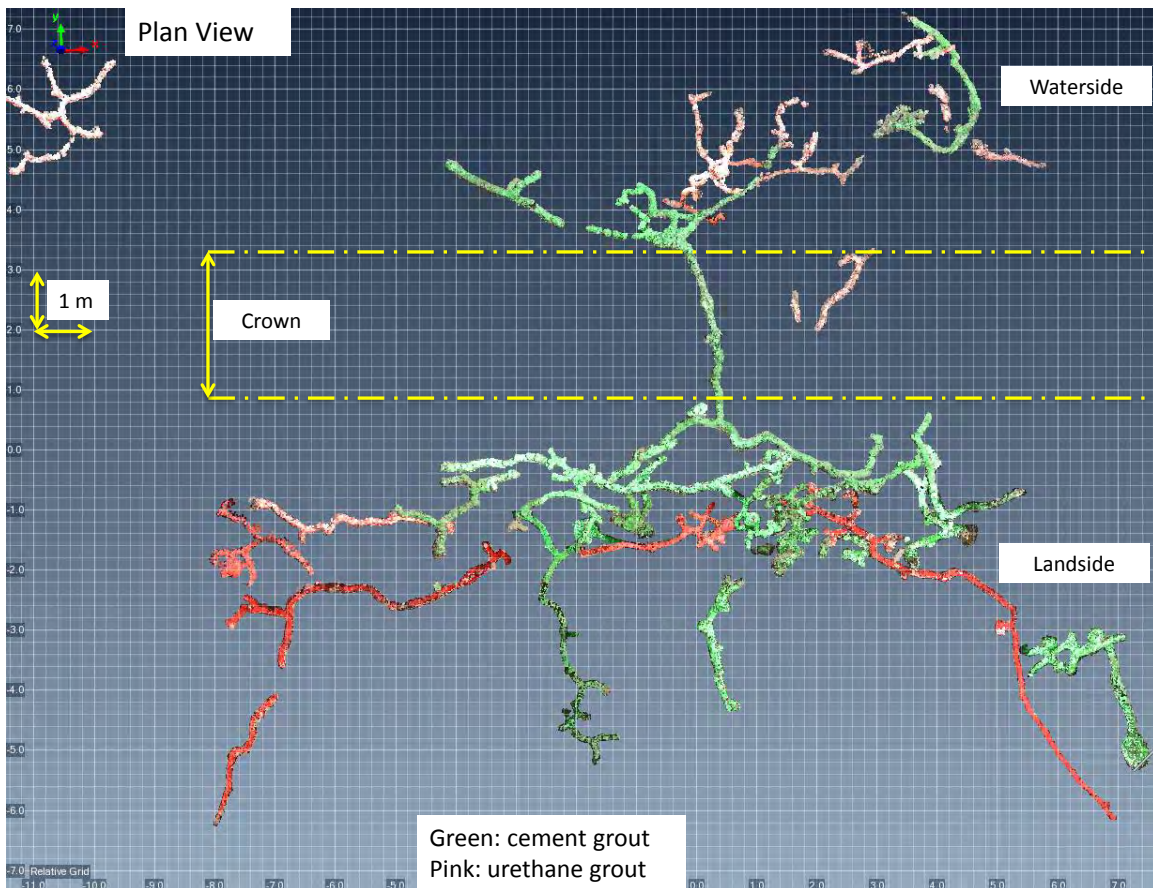
Figure 6-2. Plan view of burrow system in the clayey levee

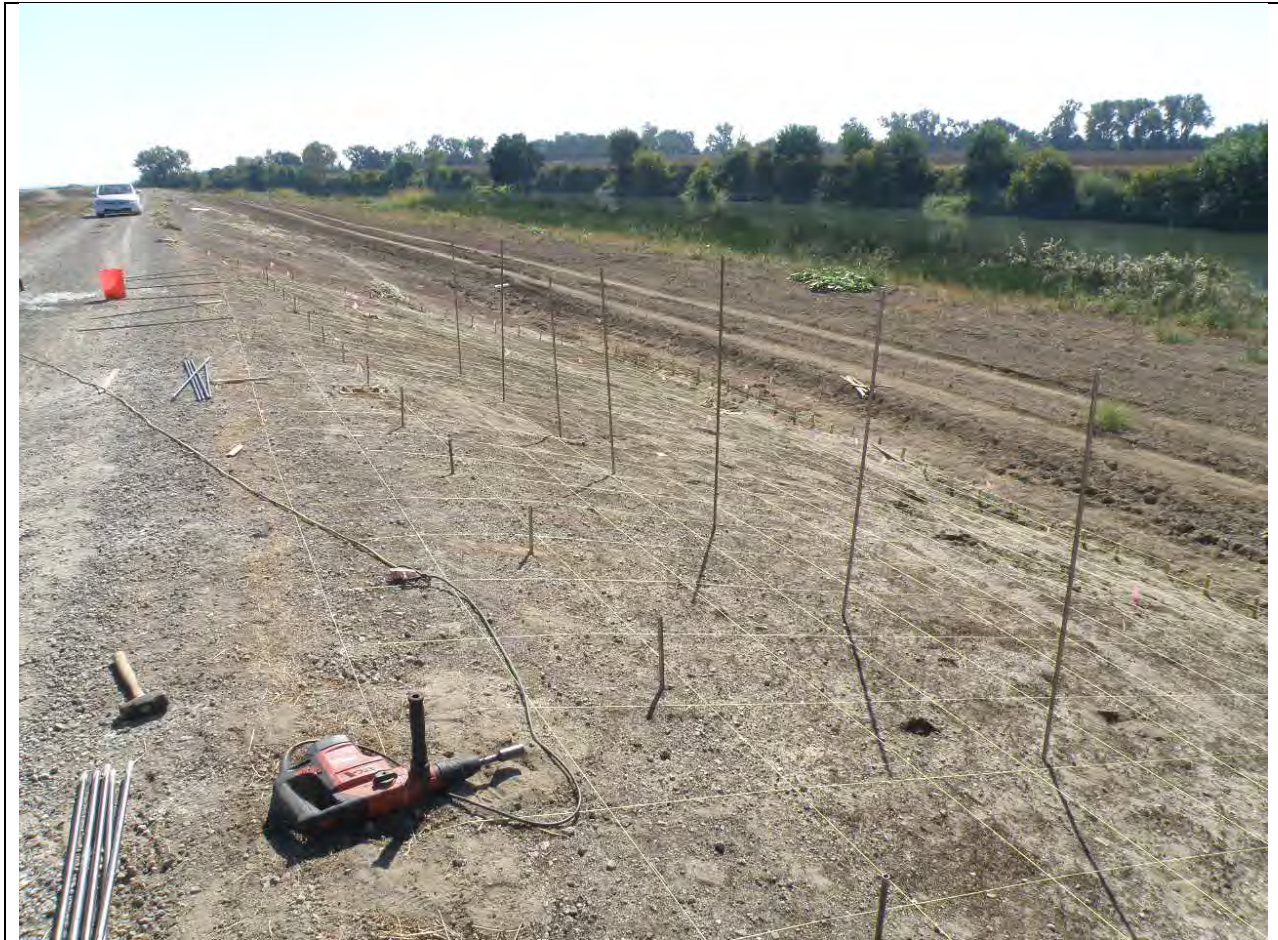
Photo 4A -7. Insertion of urethane grout injection tubes along waterside slope, sandy levee. 1.5 m (5 ft) long steel rods were spaced 1.2 m (4 ft) along the entire site.

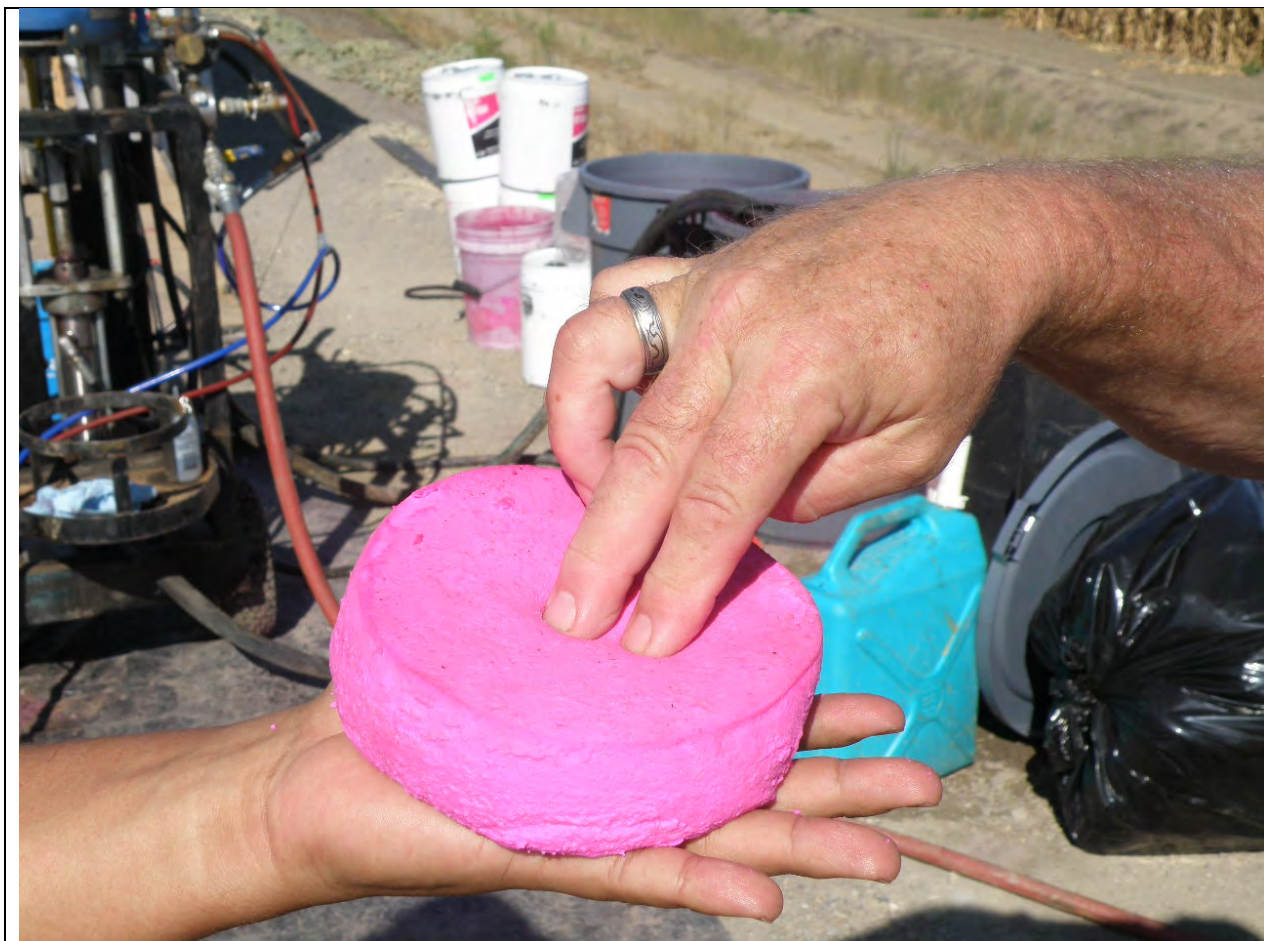
Photo 4A -8. Consistency of freshly mixed urethane grout (injected into an open container for testing), sandy levee. Pink dye was added to the mix so it would easily be captured by the T-LiDAR devices.

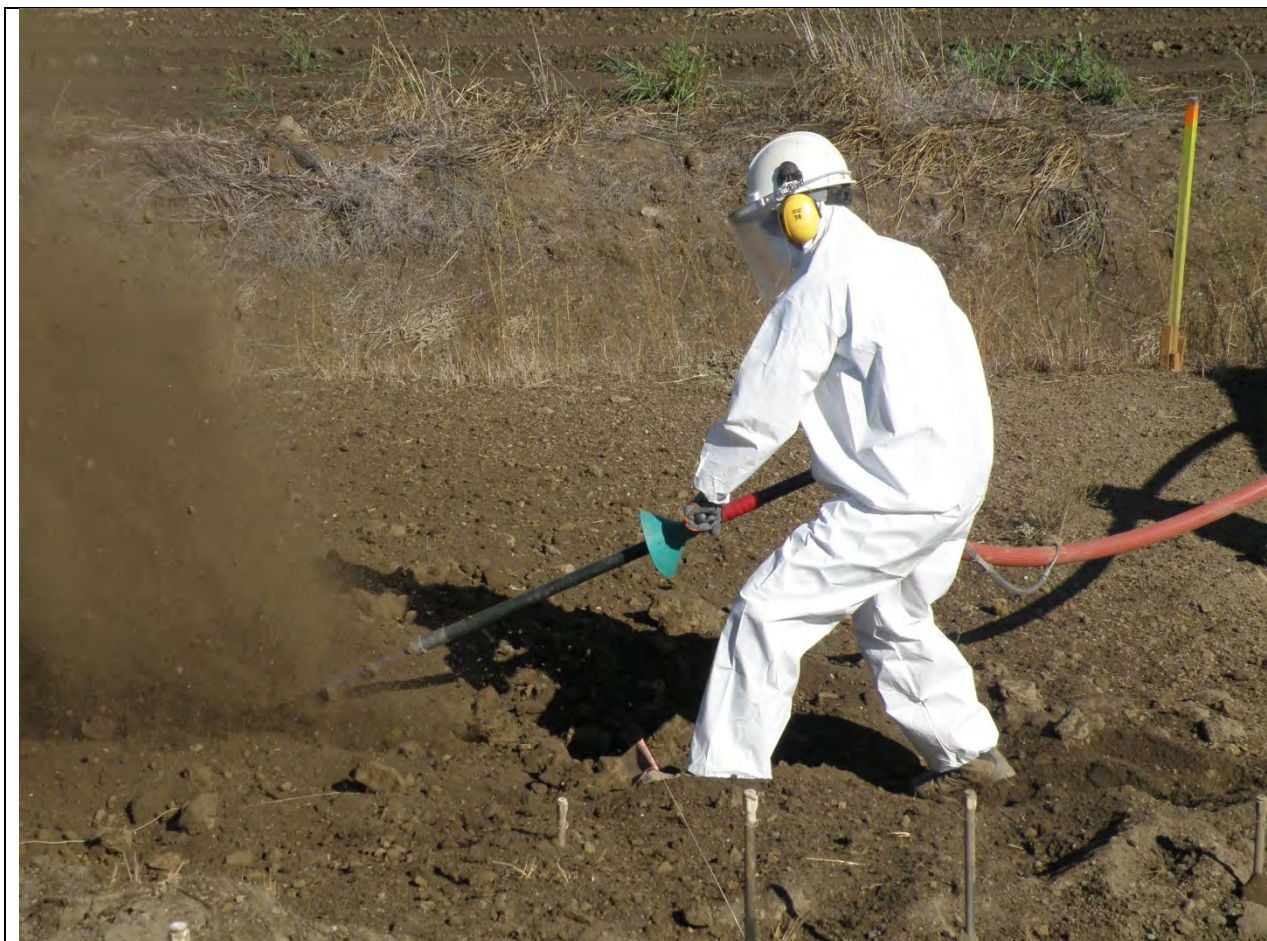
Photo 4A -9. Excavation using air-knife, Sandy Levee.

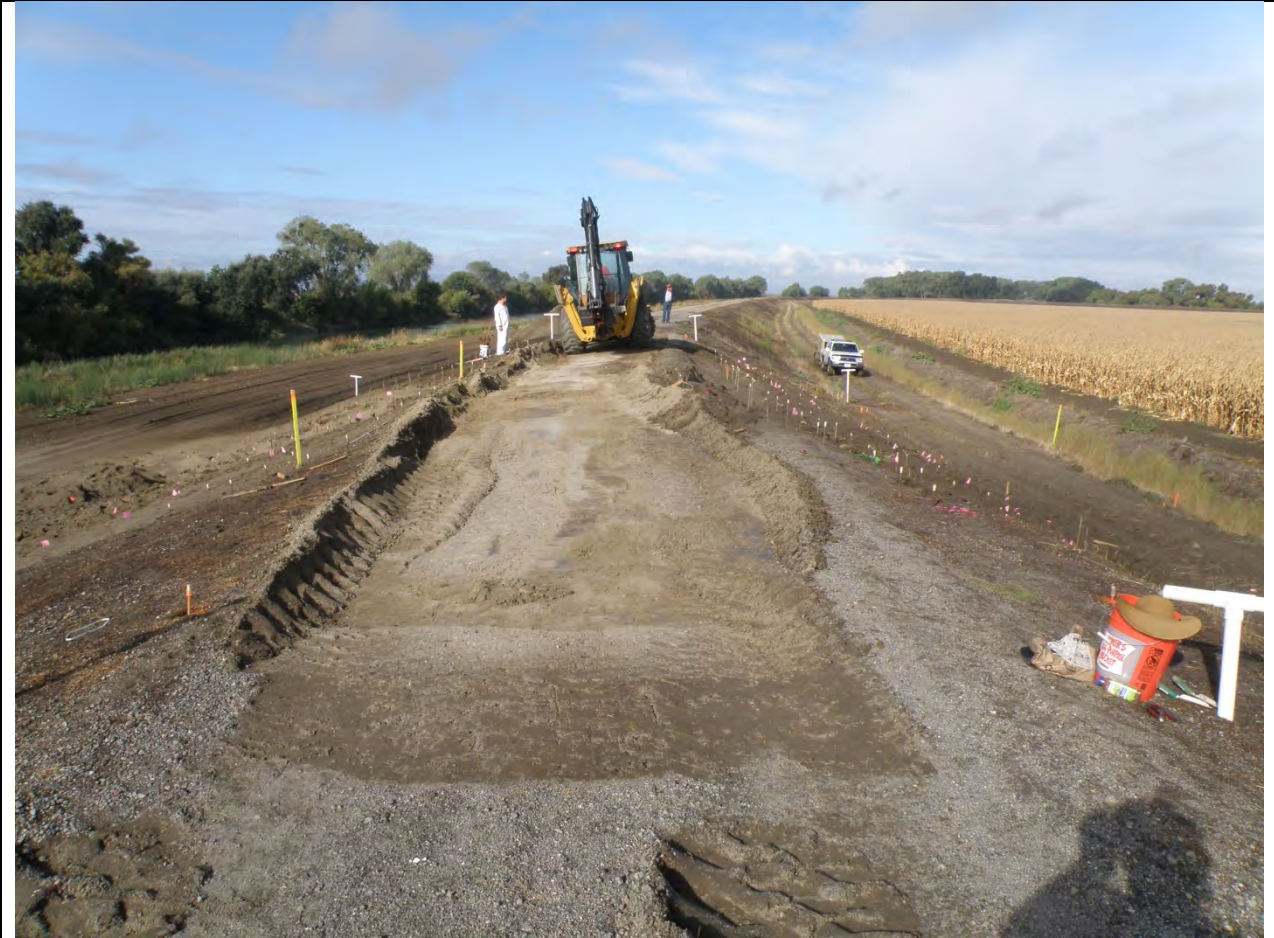
Photo 4A -10. Excavation of road base on levee crown using backhoe, Sandy Levee.

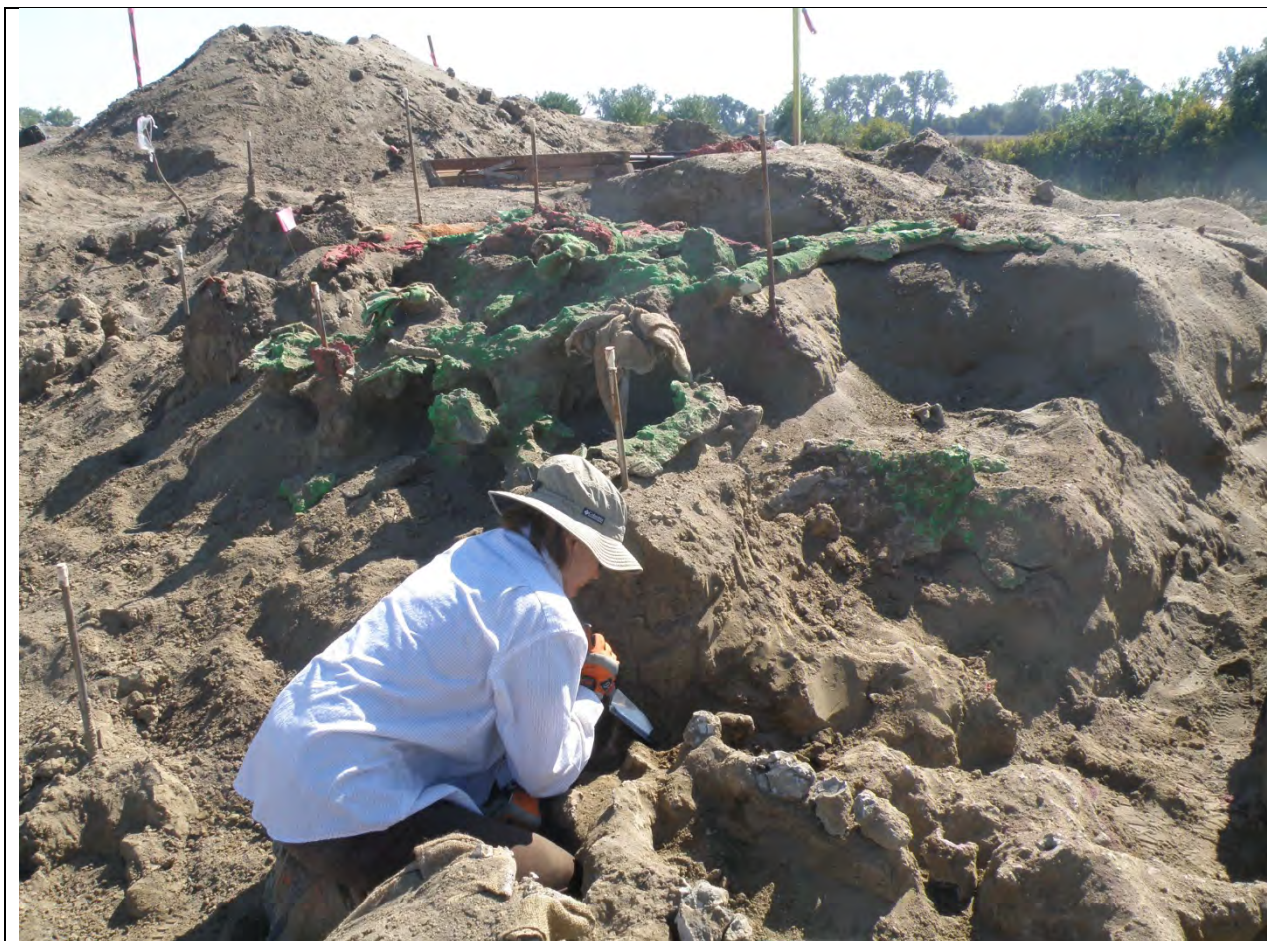
Photo 4A -13. View of landside ground squirrel burrow complex, Sandy Levee.

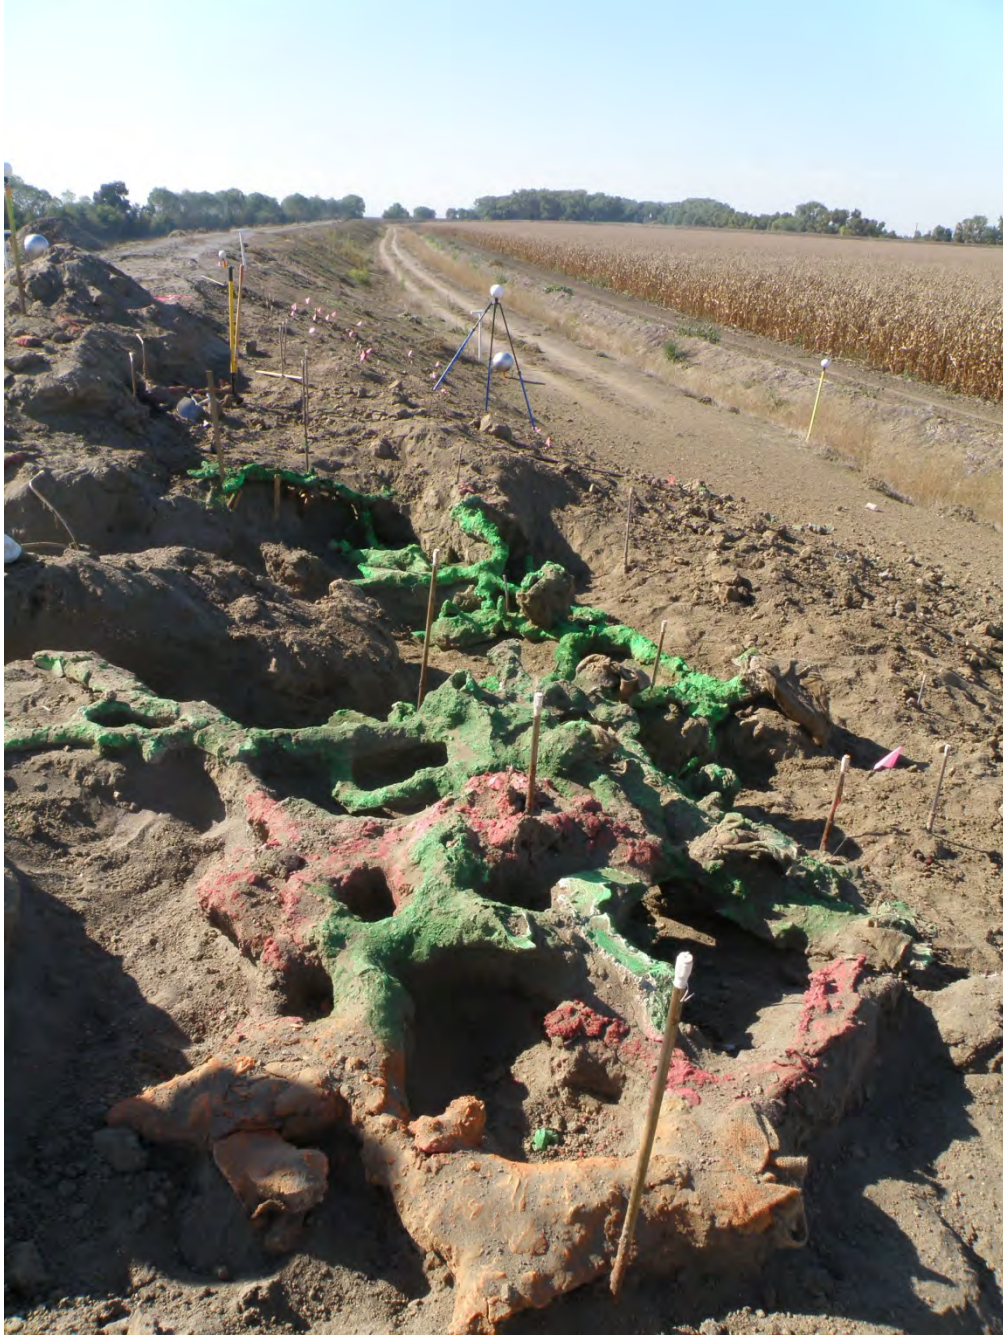
Photo 4A -15. View of landside ground squirrel burrow complex, Sandy Levee.

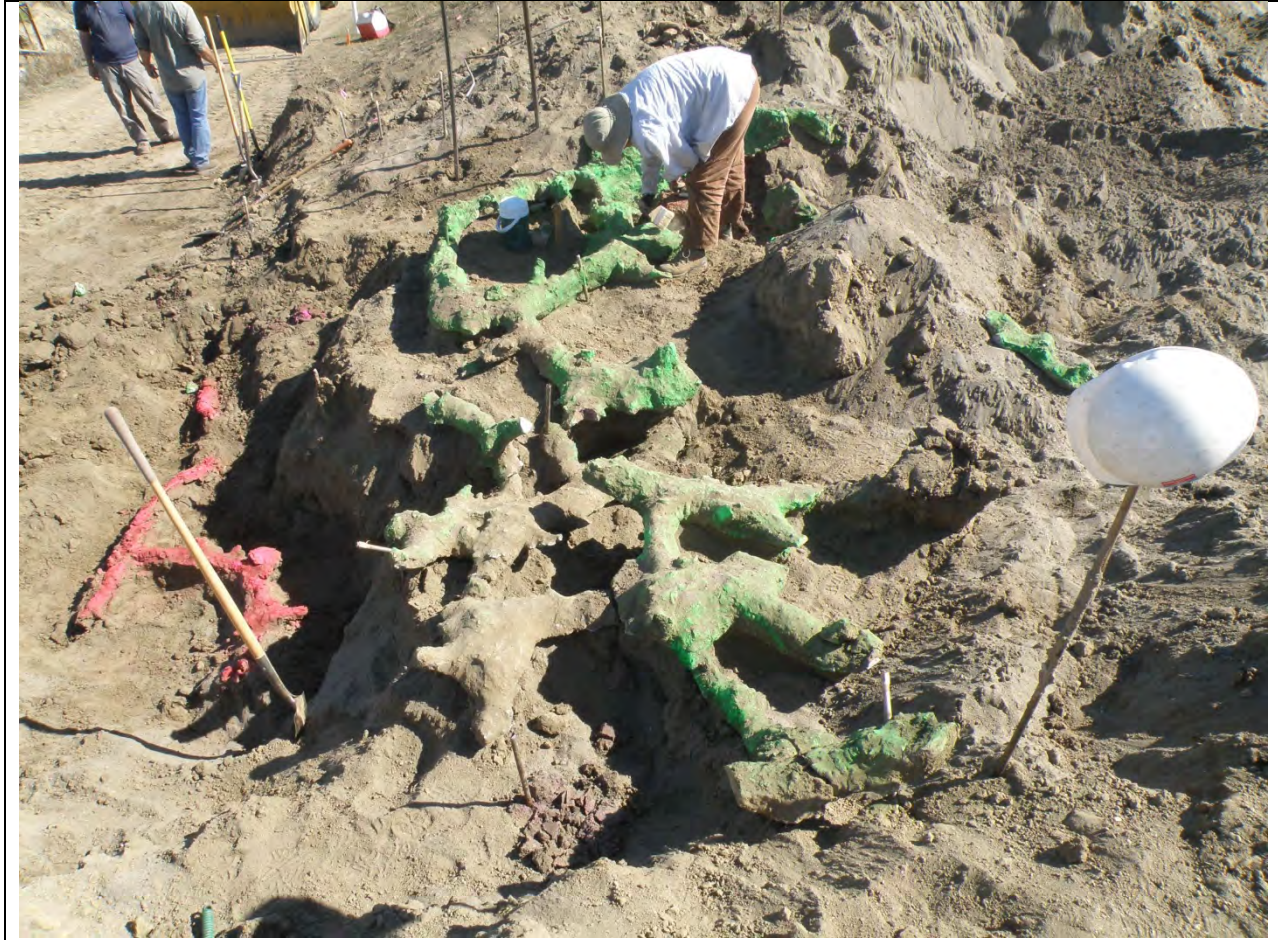
Photo 4A -16. Excavated landside toe showing urethane filled burrow, Sandy Levee.

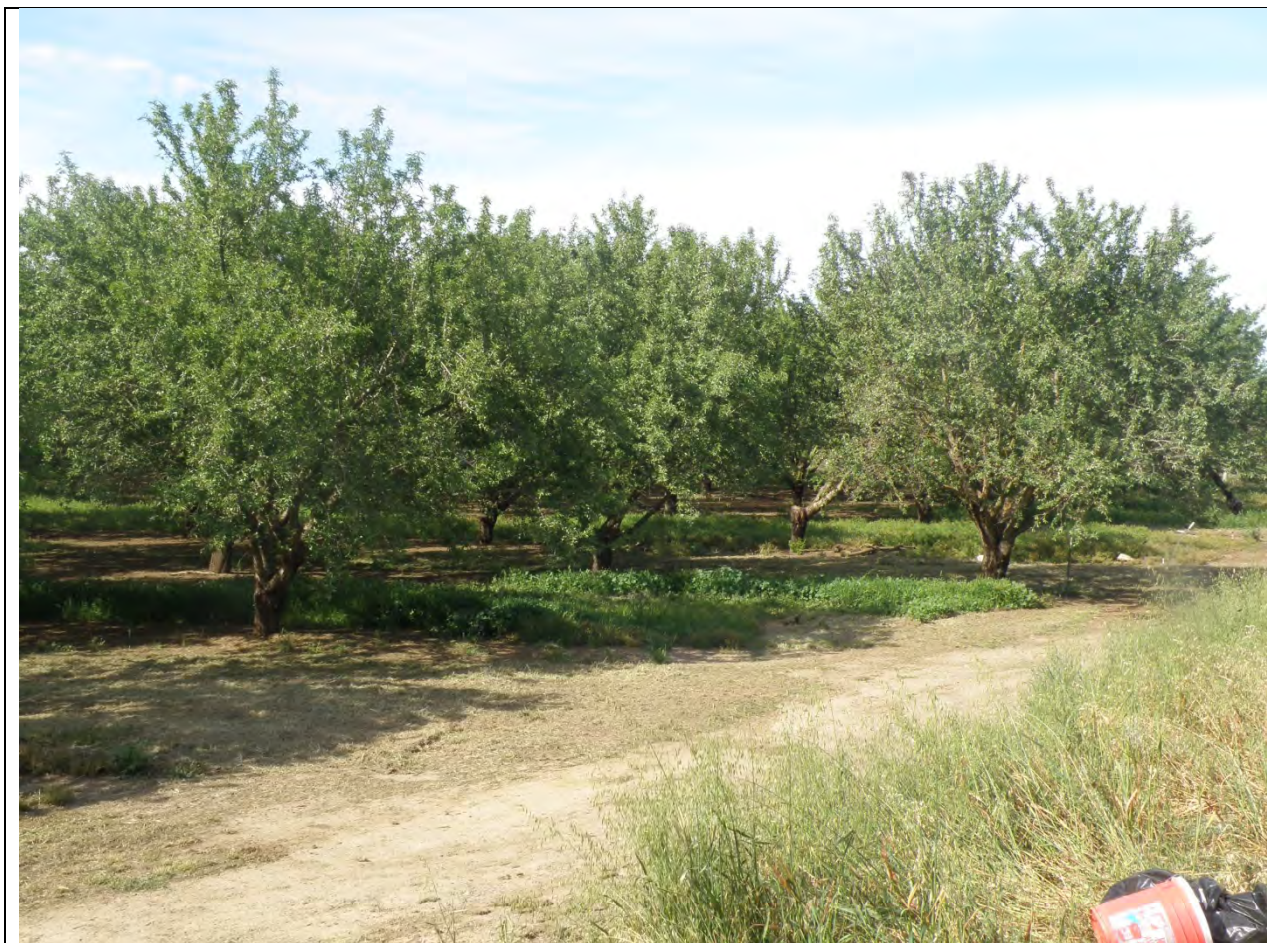
Photo 4A -20. Location of food source for ground squirrel near landside toe, Clayey Levee.

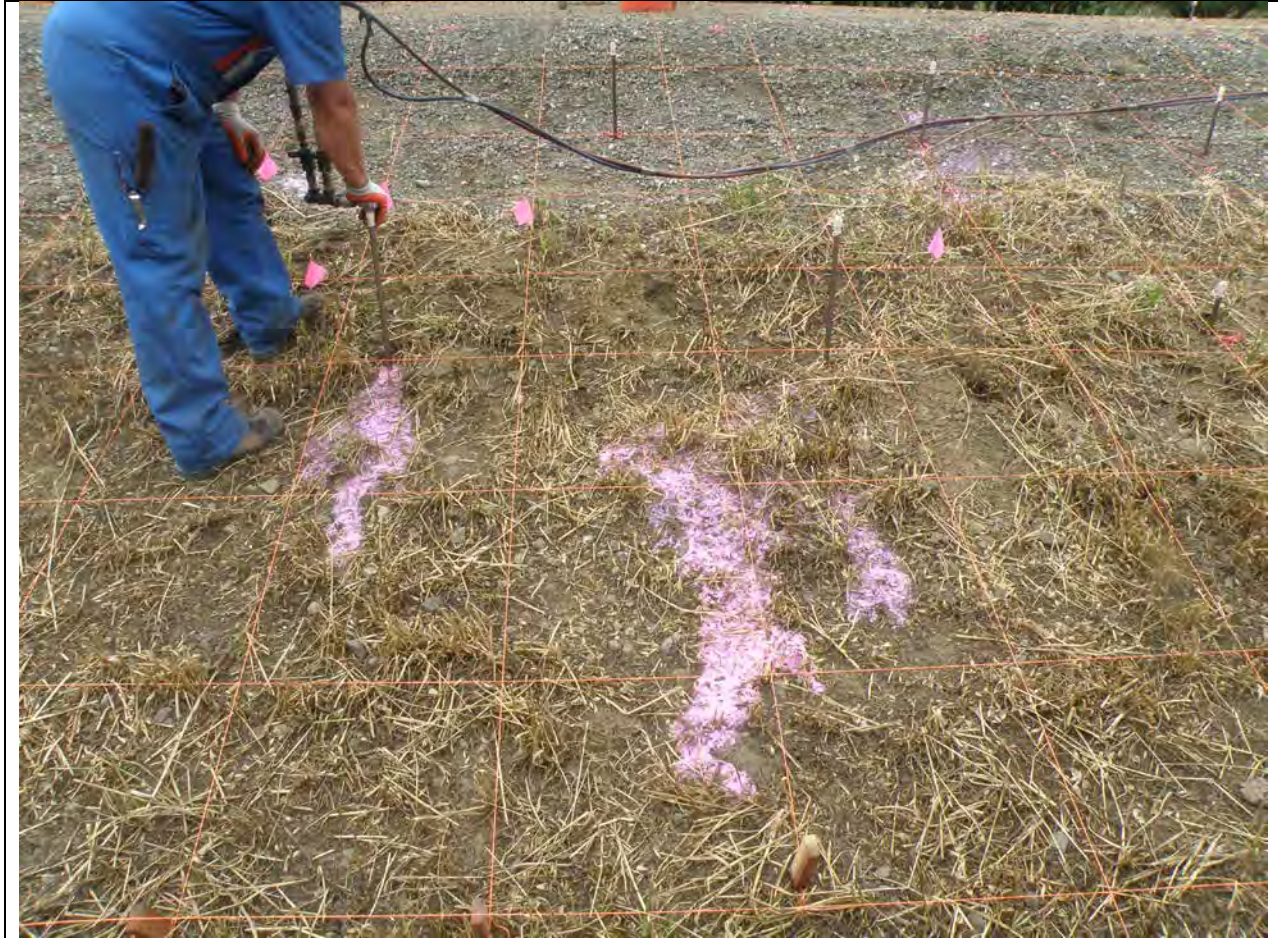
Photo 4A -21. Injection of urethane grout, Clayey Levee. Grid spacing 0.5 m

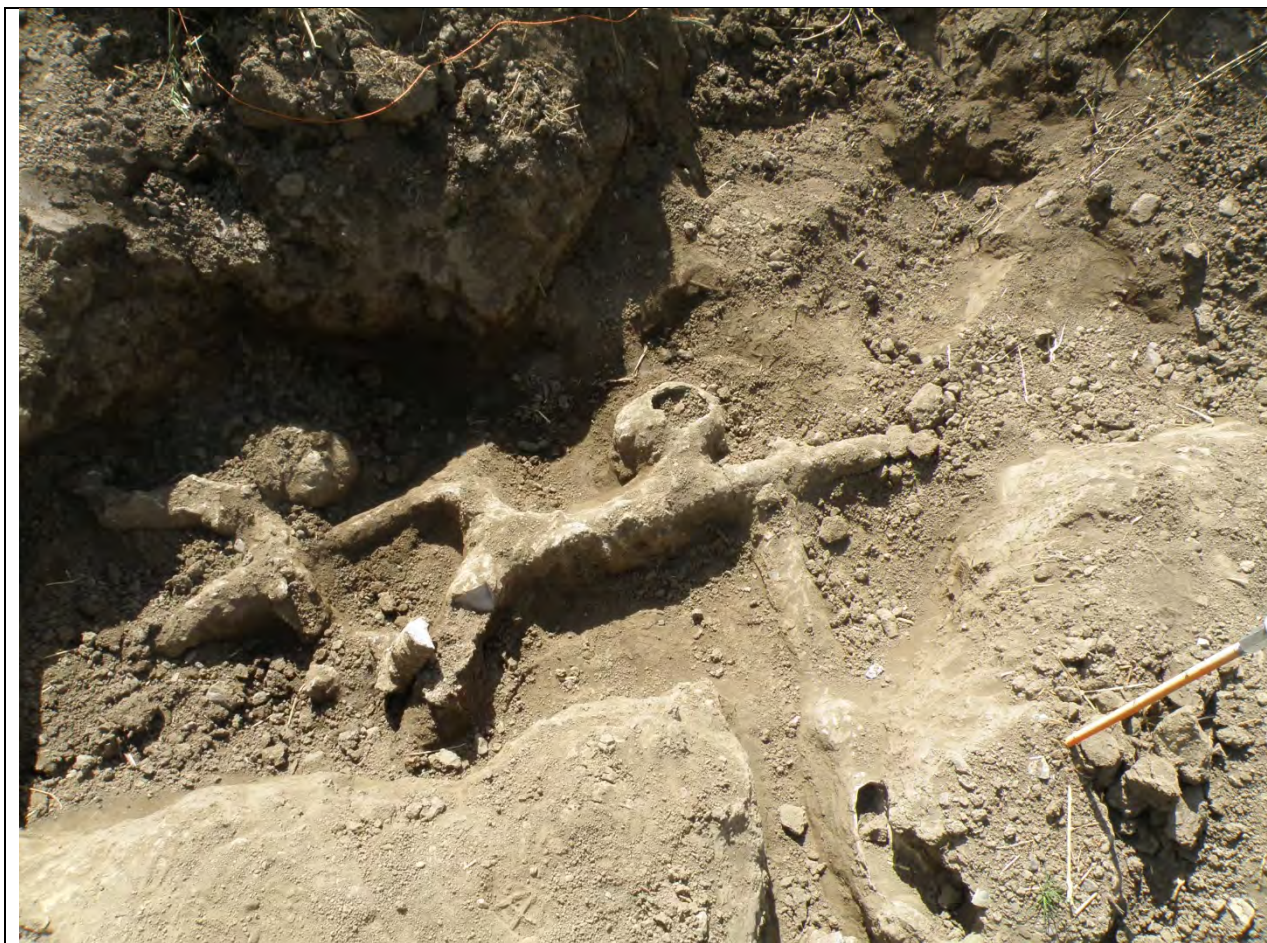
Photo 4A -22. Initial excavation of ground squirrel den near landside toe, Clayey Levee.

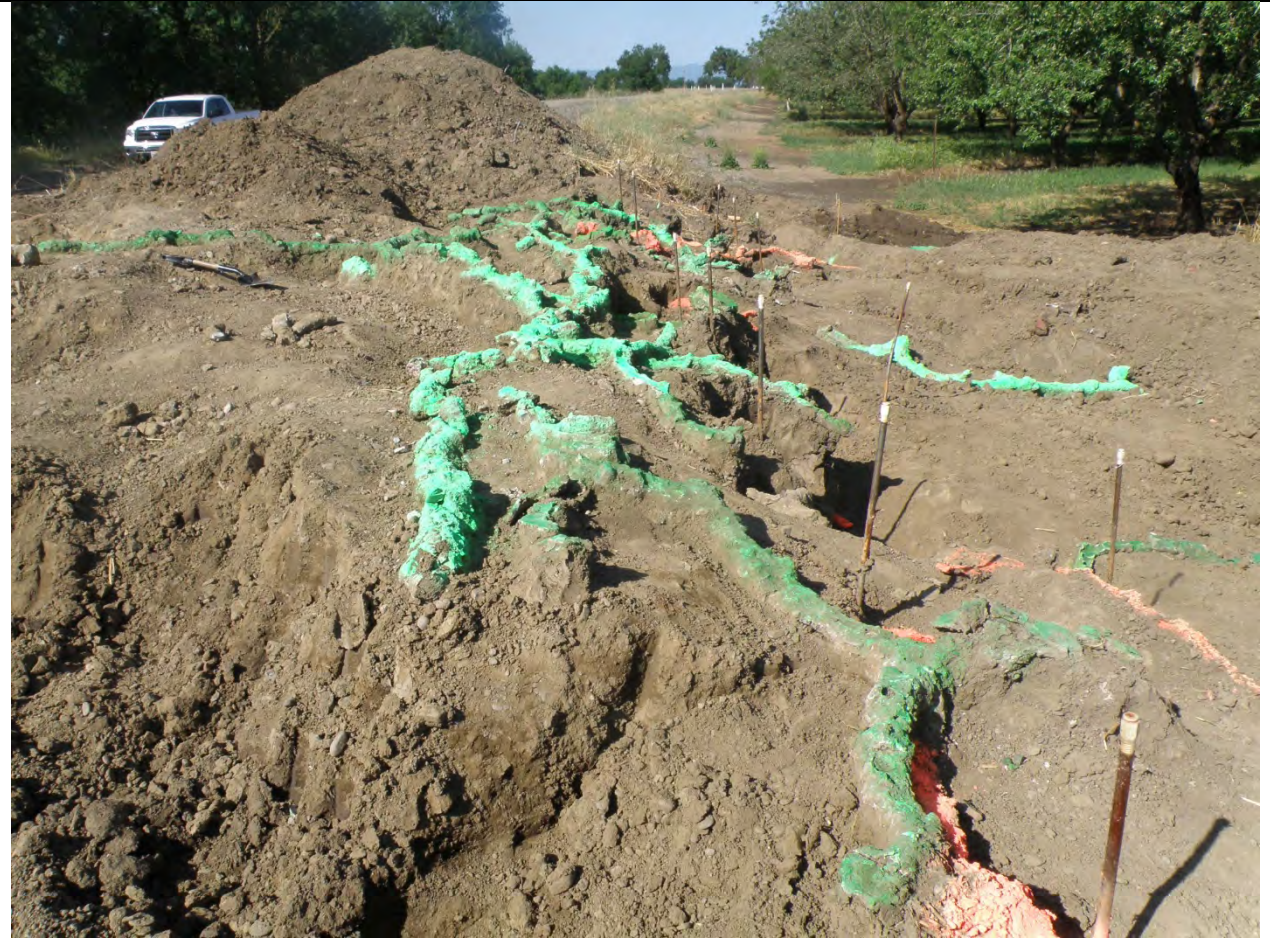
Photo 4A -25. View looking south of burrow complex along landside slope. Note proximity of food source, Clayey Levee.
